# **NATIONAL TRANSPORTATION SAFETY BOARD**

## **RAILROAD ACCIDENT REPORT**

**HEAD-ON COLLISION BETWEEN  
IOWA INTERSTATE RAILROAD EXTRA 470 WEST  
AND EXTRA 406 EAST WITH RELEASE OF  
HAZARDOUS MATERIALS  
NEAR ALTOONA, IOWA  
JULY 30, 1988**

**NTSB/RAR-89/04**

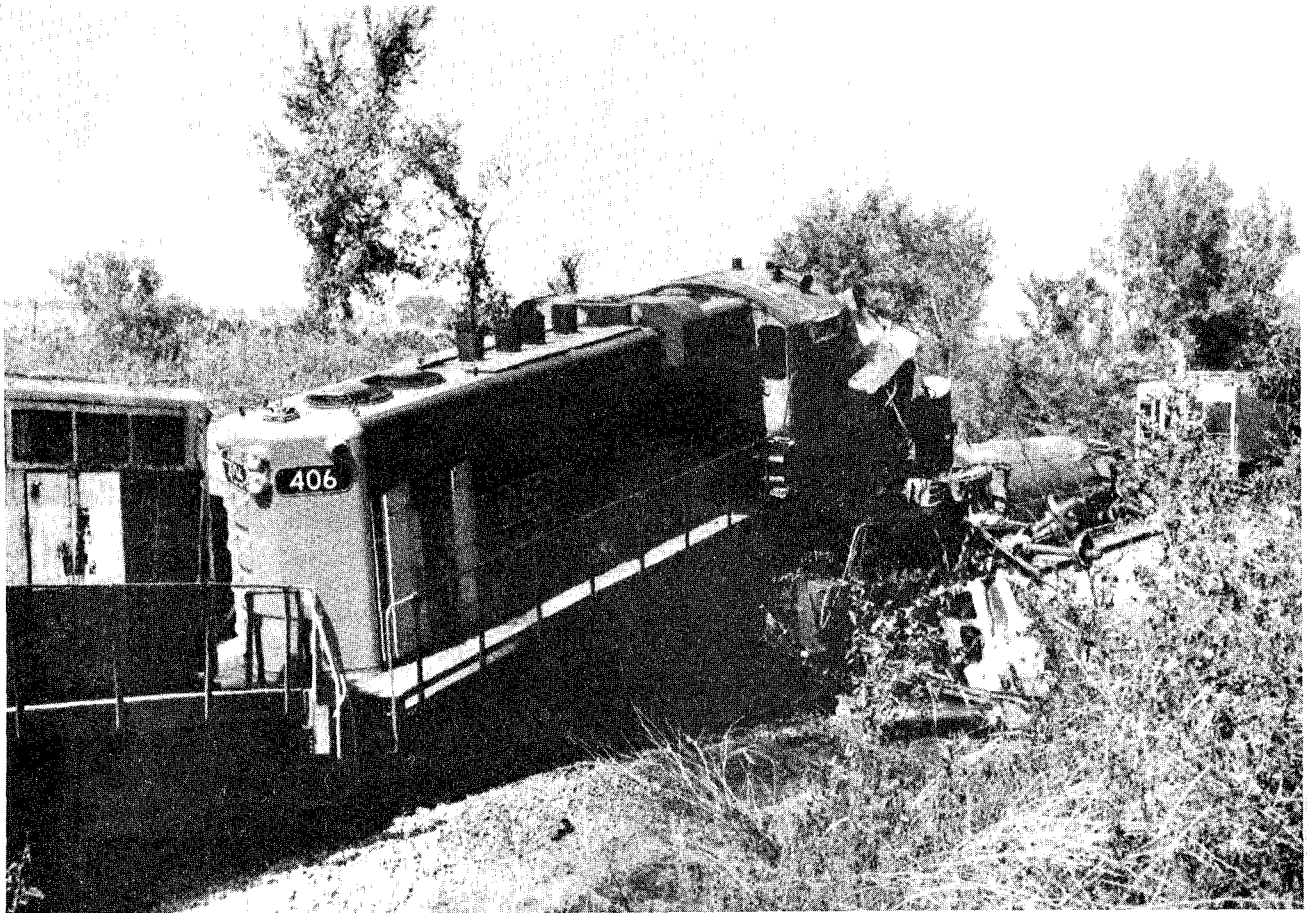
**Figure 4.--Unit 406 Overriding Unit of 470 West.**

Extra 406 East.--The lead unit of Extra 406 East received major crush damage to the front with sheet metal displacement that extended 2.5 feet to the rear. The interior of the cab of this unit was destroyed by the post-accident fire. The remaining units received light to moderate damage. The trailing unit received damage when it was struck and overridden by the first car of the consist. Three of the 11 cars that derailed were destroyed.

was operating westbound with its long hood forward. As a result, the fuel tank on unit 406 was damaged. With the exception of slight deformation to the rear cab door, the cab compartment structure remained intact. The postcollision fire, however, destroyed the interior of the cab compartment.

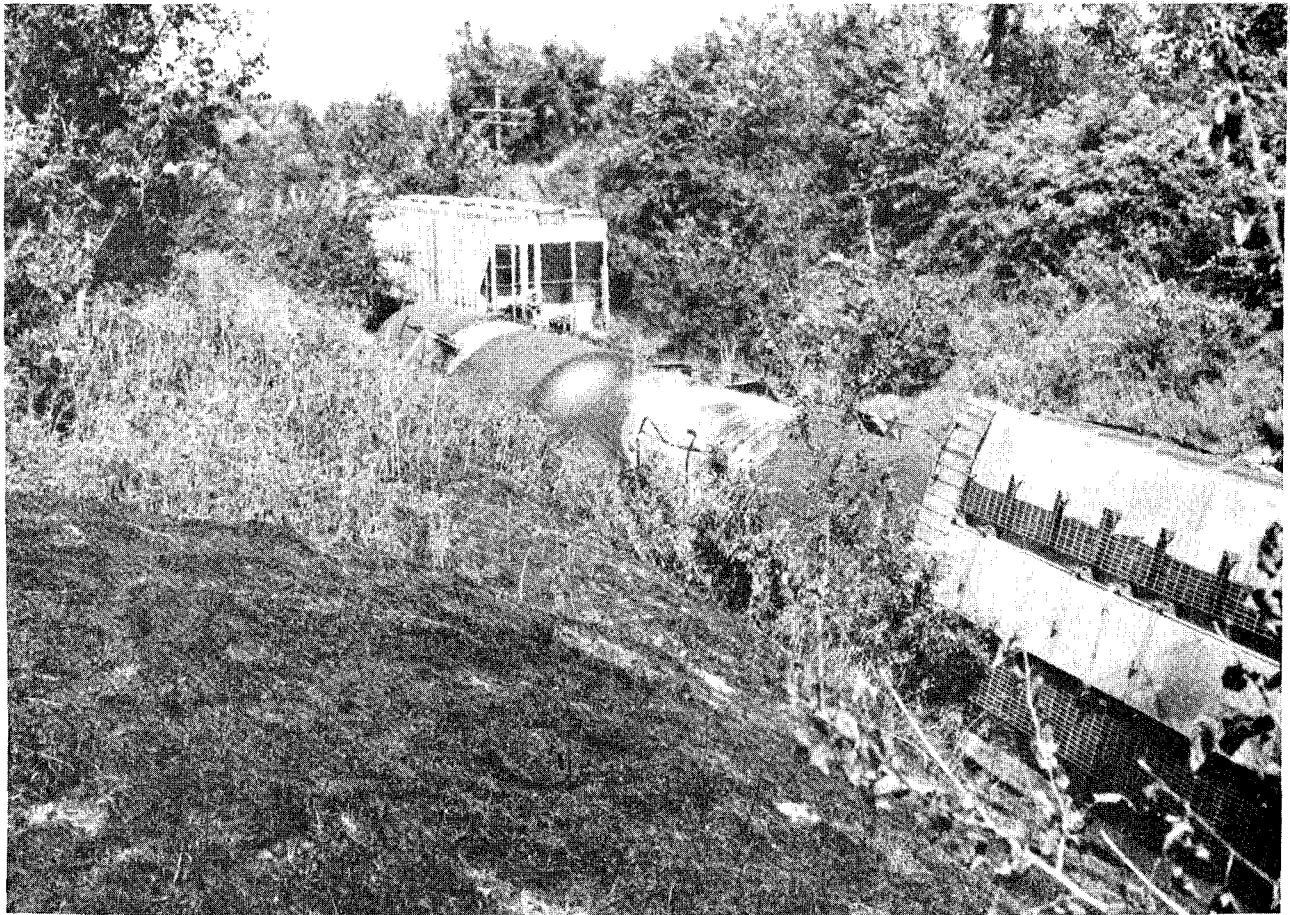
**Figure 7.--Burning at Manway Cover of ADMX 29477 (foreground) and ADMX 29494.**

A field inspector for the Association of American Railroads (AAR) arrived in Altoona about 9:20 p.m. on July 30, at the request of the IAIS to provide technical assistance. Upon arrival, he proceeded to the accident site to inspect the tank cars and noted that both cars were burning "from the dome areas and out of the safety valves."

The postaccident visual inspection of the two tank cars on the afternoon of August 2 revealed a dent in the tank shell head at the B-end, or leading end, of ADMX 29477, the lead tank car (second car from the head end) in the train. When facing the B-end, there was a crease on the left side of the tank shell just forward of the first circumferential weld seam in the side shell. The tank shell was scorched and burned around the manway and the pressure relief valve toward the A-end. The scorched and burned area extended about 2/3 the tank length from the manway toward the A-end and on the side of the tank that faced up on the overturned tank. The paint around the manway had been burned away, or was blistered. There was no visible

warping, buckling, or other obvious indications of structural damage to the tank shell observed. The bottom outlet valve extension and cap did not have any obvious damage. The manway cover and nozzle were not visibly warped. The area where the gasket contacted the manway cover had some unknown residue that had burned, but had no visible scars or marks.

The A-end of ADMX 29494, which had been the leading end of the car, had no visible damage. A small crease was found in the tank shell on the side that had been on the ground toward the B-end of the tank car. The tank shell was scorched around the manway opening and the pressure relief valve toward the A-end of the car. The scorched area extended around the side of the overturned tank that faced up, but it did not extend toward either end of

the tank. The paint in areas adjacent to the scorching was blistered. The bottom outlet valve extension and cap showed no visible damage. The manway nozzle and lid were not visibly warped or deformed.
