# **NATIONAL TRANSPORTATION SAFETY BOARD**

## **RAILROAD ACCIDENT REPORT**

**HEAD-ON COLLISION BETWEEN  
IOWA INTERSTATE RAILROAD EXTRA 470 WEST  
AND EXTRA 406 EAST WITH RELEASE OF  
HAZARDOUS MATERIALS  
NEAR ALTOONA, IOWA  
JULY 30, 1988**

**NTSB/RAR-89/04**

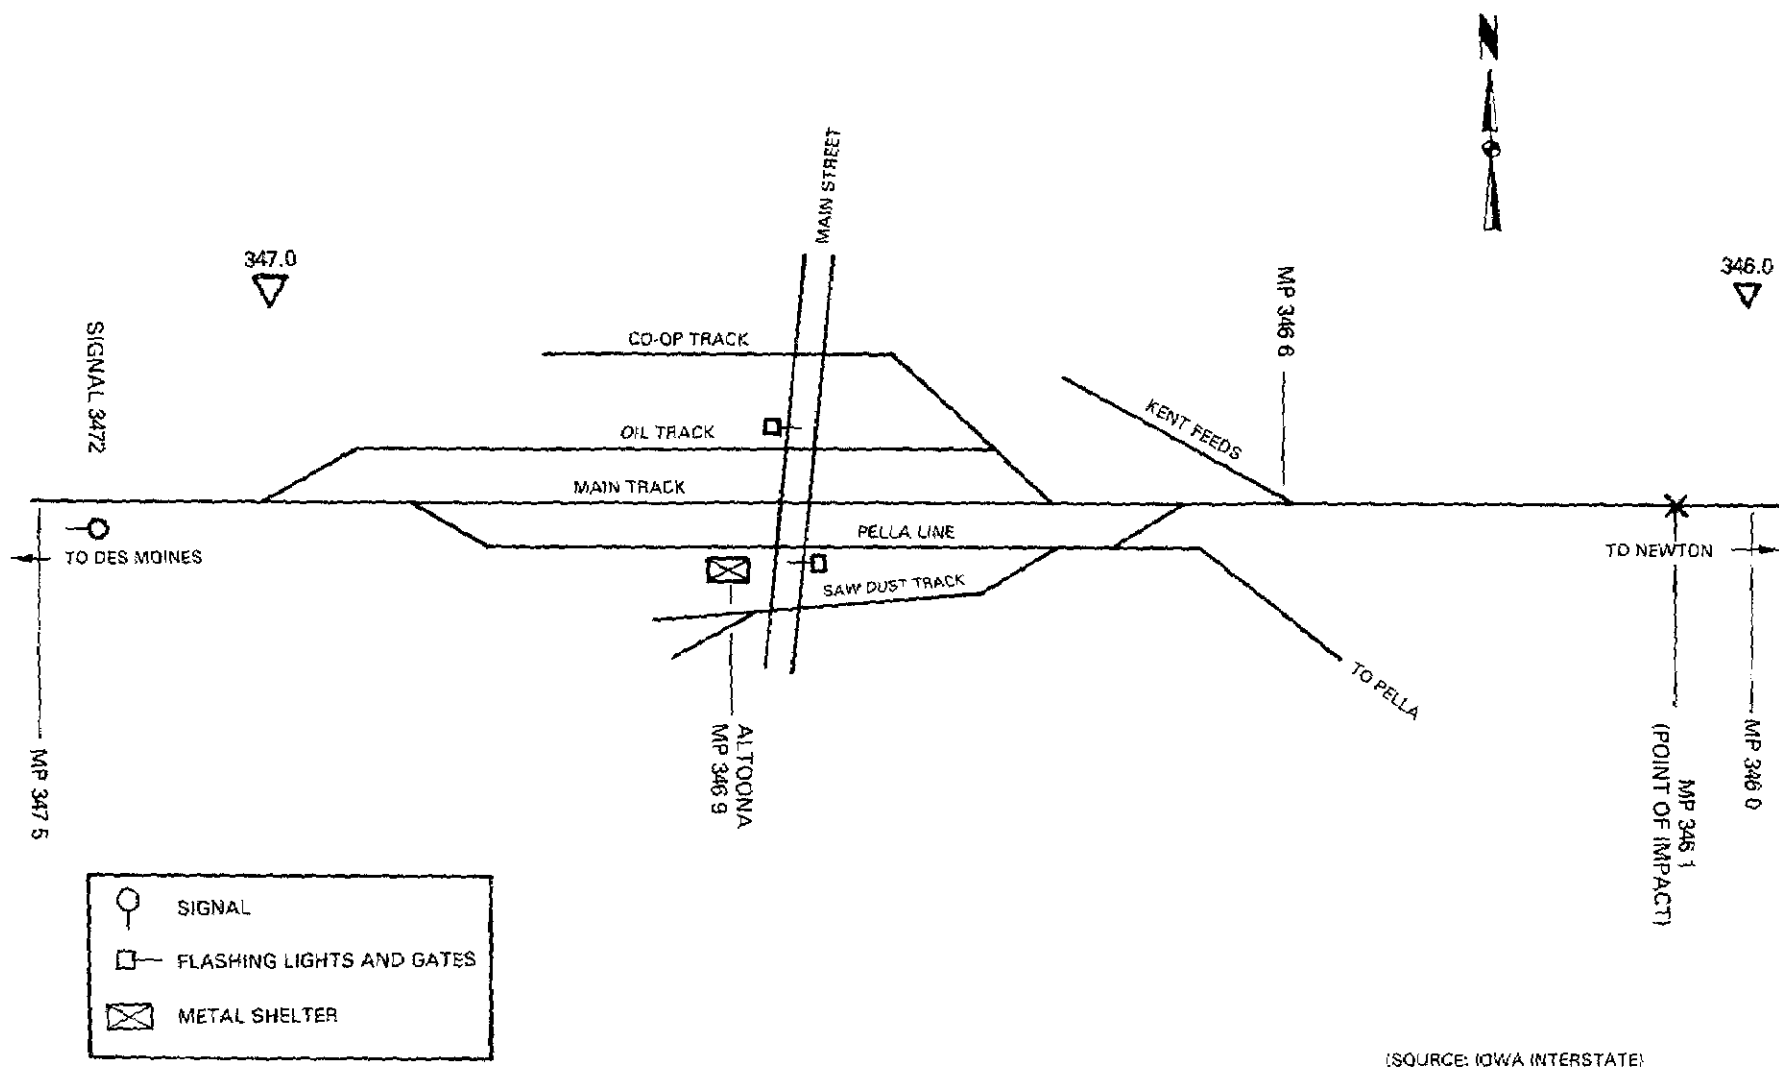
Figure 2.--Layout of Altoona Yard Track.

Safety Board investigators observed that signal No. 3472, located approximately 0.3 mile west of the Altoona station (see figure 2), had not been removed, covered, or turned away from the track.
